# STUCKI RFE-41 RESILIENT FRICTION ELEMENT INSTALLATION INSTRUCTIONS

The Stucki RFE-41 resilient friction element is a column friction snubbing assembly that replaces the Standard Car Truck Company 834-C cast iron friction wedges for 6X11, 6-1/2X12, and 7X12 Barber S-2-HD freight car trucks.

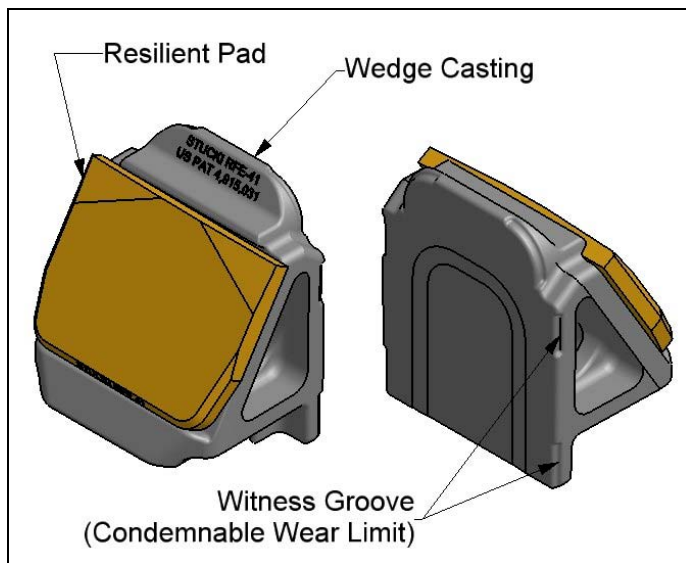
Figure 1

The RFE-41 assembly (Fig. 1) consists of an austempered ductile iron wedge element and a resilient urethane pad affixed to the sloped face of the wedge. The two pieces lock together by means of an interlocking "waffle" arrangement at the interface and an interlocking post on the pad which is retained by a tapered hole on the sloped face of the wedge. Along each edge of the vertical (or wearing) face of the wedge are witness grooves to indicate the allowable wear limits.

1. Check wear limit indicators (Fig. 1). The wedge must be replaced when either witness groove has been worn away and is no longer visible.
2. Check the top edge of the resilient pad for flush seating against the wedge surface and bolster pocket slope.
3. The top edge of a new resilient pad is 5/8" thick. Pads will assume a slight amount of permanent set in normal service. If the top edge of the pad is less than 3/8" thick, either pad or entire assembly replacement is advised.
4. Broken wedge springs must be replaced. Springs displaced from properly engaged position, top or bottom, must be corrected as soon as possible.
5. Broken, cracked, or loose column guide wear plates must be repaired or replaced as required.

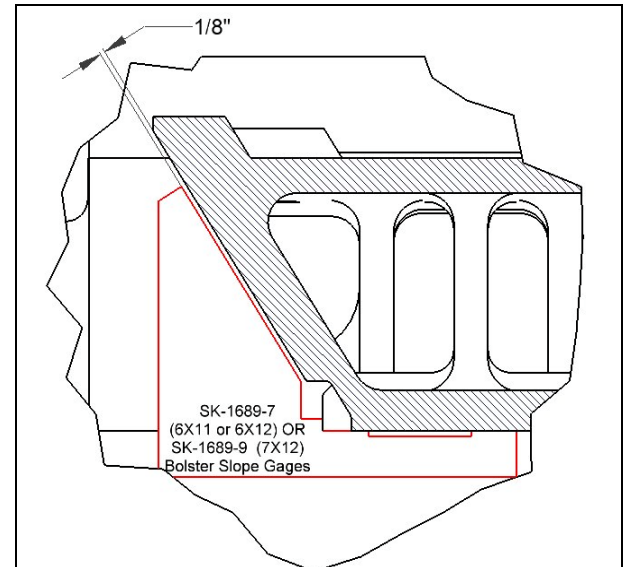
Figure 2

If a bolster pocket slope exhibits more than 1/8" wear (Fig. 2) when using Barber No. 7 or SK-1689-7 or SK-1689-9 bolster pocket slope gage, the surface must be restored either by rebuilding with weld or by addition of a 1/4" thick slope wear plate, in accordance with conventional practice. A chamfer should be applied to the top lip of the wear plate to avoid fraying the top of the pad.

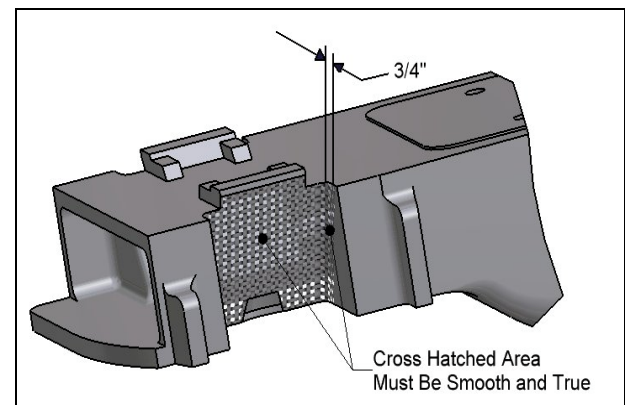
Figure 3

If the slope surface has been rebuilt, the welded area should be ground smooth and flat. This includes removal of weld spatter in the corners and on the sidewalls within 3/4" of corners (see Fig. 3).

In most cases the outboard vertical side wall of the wedge pocket in the truck bolster wears more rapidly than the inboard sidewall. If the pocket width has increased to greater than 7-1/16", the outside sidewall should be restored to the "as new" condition by rebuilding with weld in accordance with conventional practice. Only the area within 3/4" of the slope surface corners need be ground smooth (see Fig. 3).
