# STUCKI RFE-53 RESILIENT FRICTION ELEMENT INSTALLATION INSTRUCTIONS

The Stucki RFE-53 resilient friction element is a column friction snubbing assembly that replaces conventional Super Service RideMaster friction wedges on 6-1/2x12 journal freight trucks.

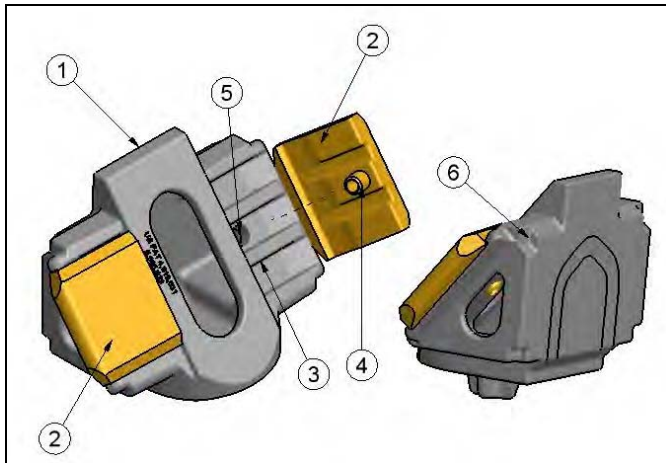
Figure 1

The RFE-53 assembly (Fig. 1) consists of an austempered ductile iron wedge ① and a pair of resilient urethane pads ② affixed to the sloped wings of the wedge. The resilient pads are interlocked to the iron wedge by means of transverse ribs ③ and tapered posts ④, which are tightly retained by tapered holes ⑤ on the wedge slopes. Along each edge of the vertical (wearing) face of the wedge are indicator grooves ⑥, to indicate the allowable wear limit.

- A. Resilient pads should be replaced on an individual wedge in pairs. Worn or damaged pads can be pried free from a wedge with a large screwdriver. New pads are installed by aligning the tapered post on the back face of the pad with the hole in the slope face of the wedge and striking the pad face with a mallet until the pad is seated flush against the wedge slope.
- B. If the pads have become noticeably melted, it is virtually certain that the subject truck has experienced substantial high-speed hunting. Replacing the pads will not correct the truck deficiency that allowed the hunting to occur. A close inspection of the entire truck, and in particular, the constant contact side bearings, should be made to find the cause of the problem.

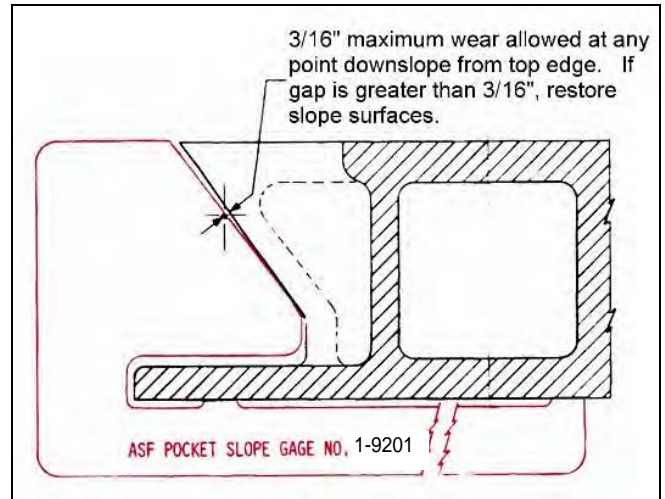
Figure 2

If bolster pocket slopes exhibit more than 3/16" wear at any point from the extreme top edge when referenced to an ASF angle gage No. 1-9201, slope surfaces must be restored by rebuilding with weld in accordance with conventional practice. Hard-faced weld rebuild is not required for RFE-53 application.

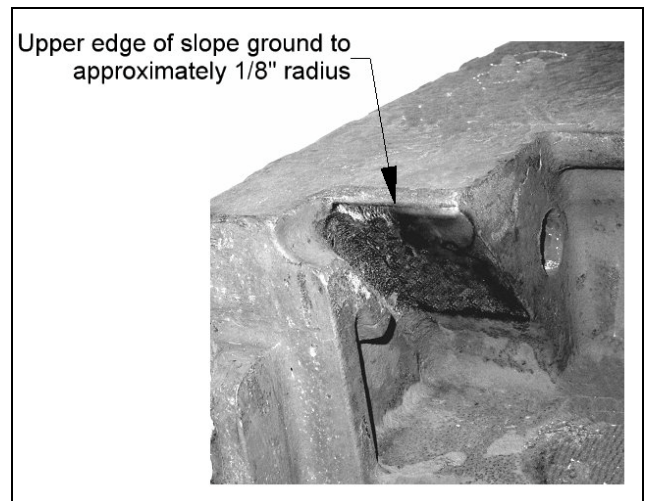
Figure 3

When slope surfaces are rebuilt, the welded areas must be ground reasonably smooth and flat. This must include removal of all significant weld spatter in corners. The top edge must be rounded off by grinding to approximately 1/8" radius (see Fig. 3).
